ENSURING STEEL QUALITY

### Surface inspection system helps prevent steel strip breakages

### SMARTVIEW DETECTION SYSTEM FOR PREVENTION OF STRIP BREAKAGES

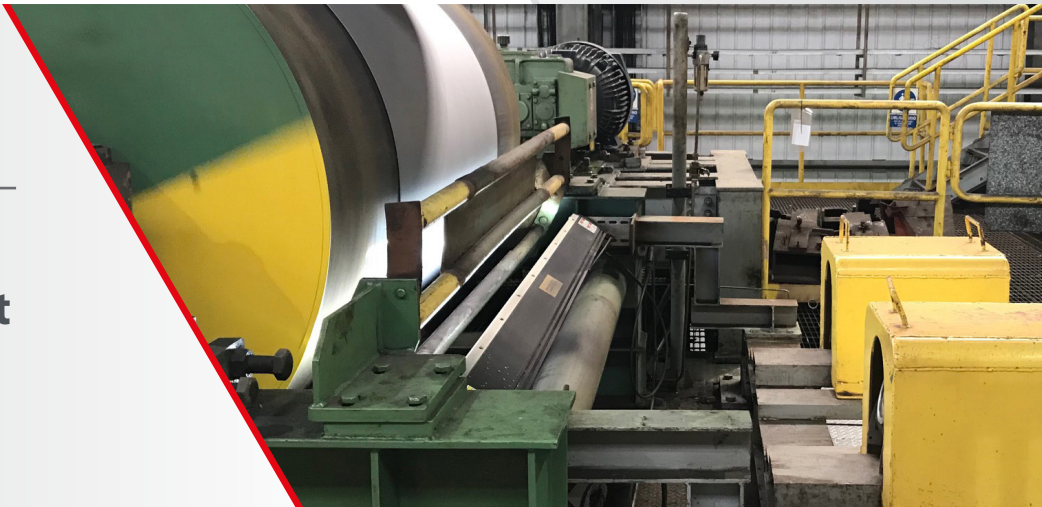
Figure 1: The SmartView system at the end of the pickling line in the Ternium Pesqueria steel plant

At the beginning of operations at the plant, AMETEK Surface Vision's SmartView system was installed to monitor surface quality issues and provide traceability for all processed coils. The system uses four cameras, two each side,

installed in bright field mode just after the pickling process.

The inspection system was originally planned as a stand-alone, so it was installed with no direct communication with the line's programmable logic control (PLC) system.

Following the SmartView system, there is a looper, beyond which is a manual inspection station. The steel strip passes in front of the quality inspector at 300 meters per minute, so it is impossible for the human eye to inspect the whole surface.

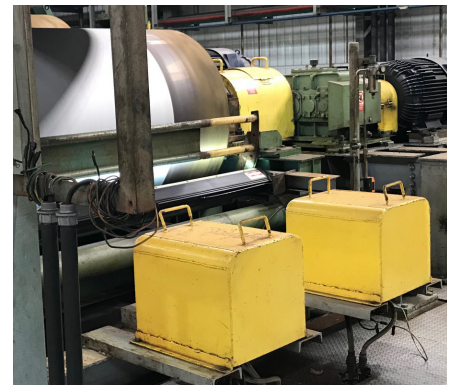
**Figure 2**  
The SmartView system has helped reduce the frequency of strip breakages

**Oziel Samaniego, Maintenance Engineer at Ternium Pesquera,** said: *"Since making the changes to the PLCTM system, there has been a steady decline in the frequency of strip breakages. If the SmartView system was not in service for any reason, we simply couldn't operate the line for thin gauge or exposed quality steel – the risk would be too high."*

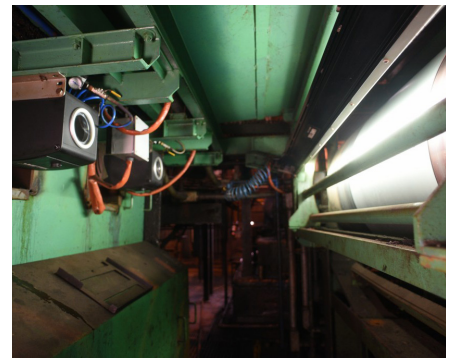
**Figure 3** A SmartView system in operation on a pickling line
